BELZONA PROTECTS AUGER SCREWS AT CEMENT PLANT

Application: SHM-Solids Handling Machinery

Customer Location: Cement Producer, Lithuania

Coal transporter at cement plant.

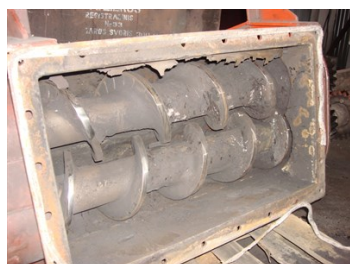
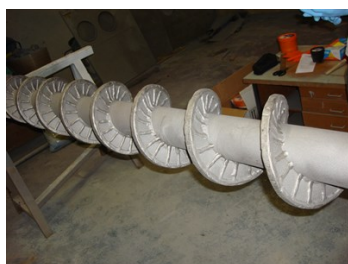
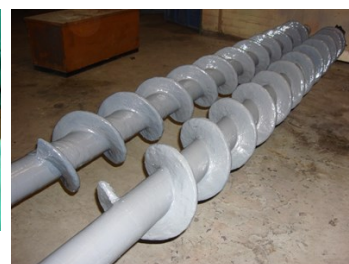
The auger screws suffer severe abrasion and client needed an effective protection system.

- * General view of screws after 1 year in service ,
- * The view after surface preparation ,
- * Belzona® 1812 application on both sides of helical outer surfaces ,
- * Belzona® 1321 application and completed job ,

Application of Belzona® 1321 on top of the Belzona® 1812 gave smoother finish, which prevented the damp coal sticking to the screw surfaces. Local repairs to high wear areas were carried out annually to maintain the screw protection until new plant was installed in 2012.
