# BELZONA RESTORES PUMP FROM SUGAR MILL

Industry: *Sugar*  
Application: *CEP-Centrifugal Pumps*  
Substrate: *Cast Iron*  
Products: *\* Belzona® 1111 (Super Metal) ,*  
*\* Belzona® 1391 (Ceramic HT) ,*

Customer Location: *Major Sugar Producer, South Africa*  
Application Date: *March 2010*

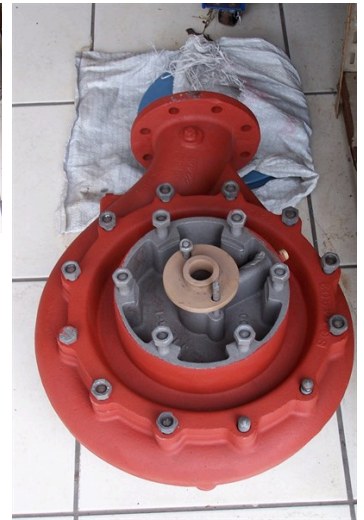
*Customer looking to repair badly eroded back plate & volute and to coat new Impeller*

- \* Pump after grit blasting ,
- \* Baddly worn cut water and hole through volute ,
- \* Finished Application ,
- \* Pump assembled and ready for despatch ,

Application was carried out in accordance with Belzona Know-How System Leaflets CEP-1, 3 & 5.

Conventional weld repairs difficult on cast iron. Belzona provides effective rebuild and restoration of profiles without risk of distortion and Belzona® 1391 provides excellent erosion corrosion protection at the pumps 80 °C operating temperature.
