# BELZONA USED TO RESTORE CORRODED FLANGE ON CHIMNEY

ID: 144

**Customer Location:** Fertilizer manufacturer in France  
**Application Date:** August 1996

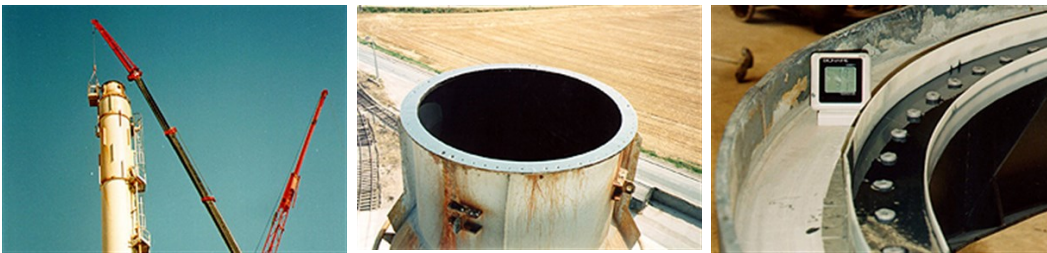
The flange faces and the removable gasket had been attacked and corroded by the chemicals passing through the unit. In places the depth of corrosion on the flanges was 20-30mm.

- \* The difficult working situation on the chimney ,
- \* The flange rebuilt and protected ,
- \* Belzona® 2221 used to cast new gasket ,

Application was carried out using suitably modified techniques covered in Belzona System Leaflets GSS-2, VPF-1, 2 & 13.

Ease of use was an important factor given the difficult working situation. The excellent chemical resistance of Belzona® 4311 has prevented further corrosion occurring on the flange.
