# BELZONA PROVIDES ROOF PROTECTION

ID: 1443

Application: RPA-Roof Problem Areas

Customer Location: Software Distributor, UK

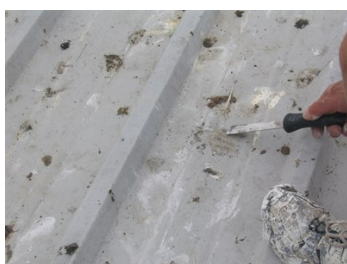
- \* Corrosion issues due to bird litter on roof extension ,
- \* 1990 application unaffected by bird litter ,
- \* 2005 application completed ,
- \* 2010 still is perfect condition ,

The original roof was completed in 1990 by the local Authorized Contractor. It was possible to see corrosion as a result of bird litter on sheets of the new extension but on the Belzona® 3111 Membrane System it has had no effect on performance although a wash would make it more aesthetically pleasing. As a result of the success on the original roof, the extended building was then encapsulated and the existing system refurbished to provide a further 15 years life.
