BELZONA PROTECTS A POWER STATION CHIMNEY STACK

Customer Location: Coal Fired Power Station, Yorkshire, England

Application: WPA-Wall Problem Areas

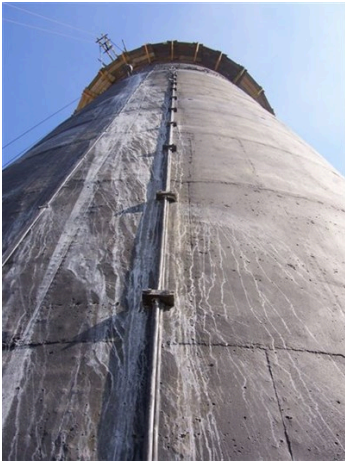
Existing coating was beginning to degrade due to exhaust gases and ultra-violet (UV) breakdown combined with inclement weather.

* Existing coating degrading Application of Belzona® 5111 Completed application in 2008 Application revisited in 2010 ,
