COOLING TOWER FAN BLADES REPAIRED WITH BELZONA PRODUCTS

ID: 1445

Customer Location: Fertilizer Producer, Indonesia
Application Date: February 2010

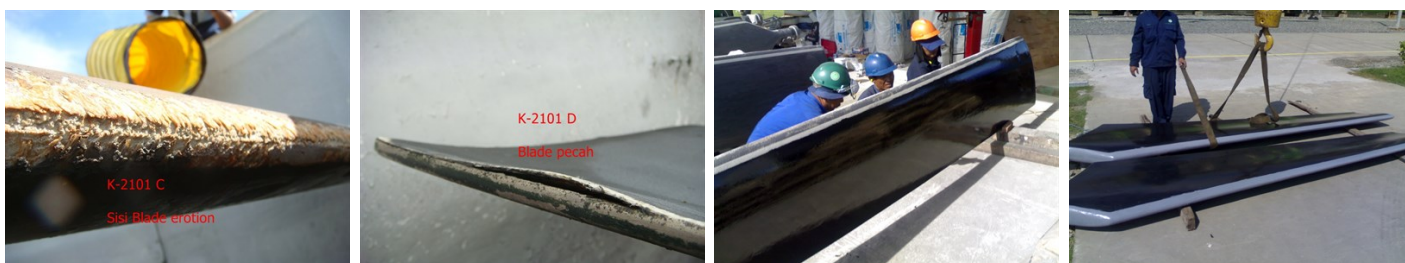
Photograph Descriptions

Erosion on leading edges, cracks and flaking on trailing edges of cooling tower fan blades caused by UV degradation, erosion and impingement. This reduces the overall efficiency and operation of the cooling system.

- * Damage on leading edges ,
- * Flaking on trailing edges ,
- * Belzona application ,
- * Completed blades after coating with Belzona® 1321 and Belzona® 5811 ,

The application was carried out in accordance with Belzona Know-How System Leaflet FBC-1. The Leading edges and trailing edges were rebuilt with Belzona® 1311 and subsequently coated with Belzona® 1321. Blade body was coated using Belzona® 5811.
