BELZONA STOPS ANNULAR PLATE EXTERNAL CORROSION

ID: 1448

Customer Location: LPG Tank Farm, Sharjah, UAE
Application Date: March 2006

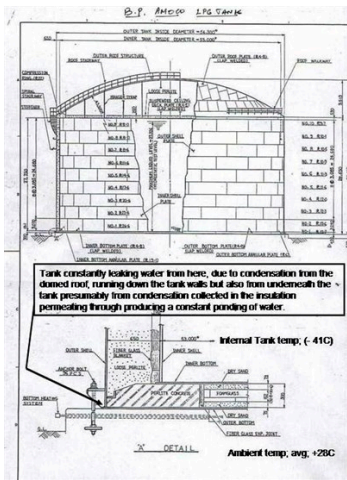
Annular plate suffering external corrosion from contaminated condensation running down the walls plus the sea water environment gathering between steel and concrete plinth.

- * Drawing of insulated LPG tank showing areas requiring protection ,
- * Application of the Belzona® 3111 System ,
- * Close up of condensation running off the annular plate ,
- * View of completed application ,
