# BELZONA® 1391 PROTECTS ABSORBER TOWER

ID: 145

Customer Location: *Steel producer in Indonesia.*  
Application Date: *May 1996*

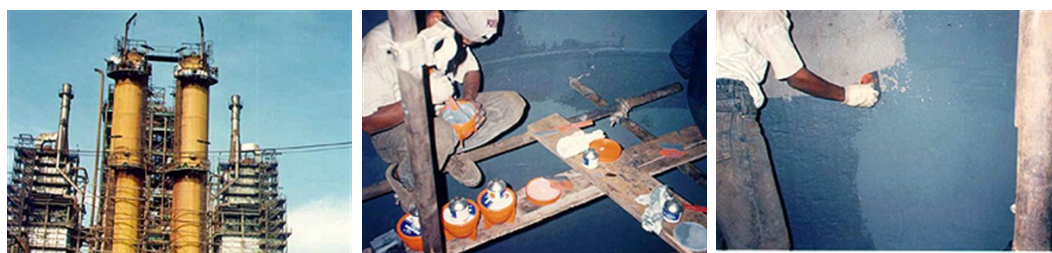
*MDEA is used at a temperature of 120°C (250°F) in this absorber and severe corrosion is experienced.*

- \* General view of the absorber tower. ,
- \* Work underway inside the absorber. ,
- \* Application of Belzona® 1391 by applicator. ,

Belzona chosen to repair critical areas as alternative to re-plating which was very much more costly and would have taken four times as long. Structure planned to be replaced after six months. In fact, replacement would have delayed for 12 months at which time Belzona® 1391 was still in perfect condition. Belzona® 1391 used on new absorber tower.
