# BELZONA REPAIR AND PROTECTION OF REFRIGERANT COMPRESSOR

Industry: *Marine*  
Application: *FBC-Fans, Blowers and Compressors*

Intercooler unit on a tugboat

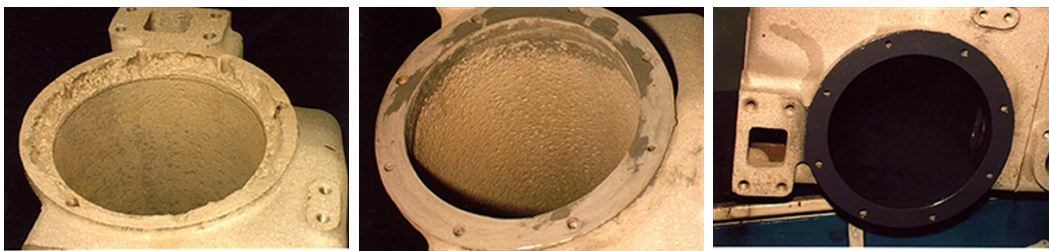
*Severe erosion-corrosion particularly around flange faces, mainly by bimetallic corrosion.*

- \* The degree of metal wastage clearly evident ,
- \* Profiles rebuilt with Belzona® 1111 ,
- \* Complete protection provided by Belzona® 1321 coating ,

Application was carried out in accordance with Belzona System Leaflets FBC-2 and FBC-5.

Units fully restored and protected without resorting to welding.
