BELZONA SIMPLIFIES REPAIRS IN GLASS LINED REACTORS

ID: 147

Customer Location: Chemical Fertilizer Plant in the Middle East

Application: TCC-Tanks and Chemical Containment Areas

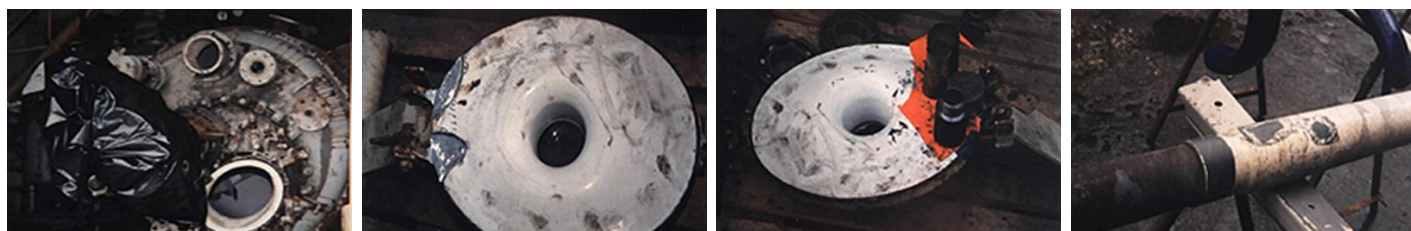
Photograph Descriptions

Damage to the glass lining caused by mis-handling of the covers and introduction of foreign bodies into the mixing process.

- * General view of the reactor ,
- * Typical damage to glass lining on cover ,
- * Repairs to cover being made. Note use of mixing board to form smooth surface on Belzona® 1311 ,
- * Local repairs with Belzona® 1311 to damaged glass protection on mixer shaft ,

Chemical Reactors operating at 120°C and 7 bar pressure.

The Belzona repair can be completed in three hours. Making and securing Tantalum patches can take several days. Belzona® 1311 is only viable repair on agitator, Tantalum patches cannot be secured.
