# BELZONA REPAIRS OIL LEAK ON TRANSFORMER FIN

ID: 1483

Customer Location: *Electricity Distribution Co. UK*  
Application Date: *2008*

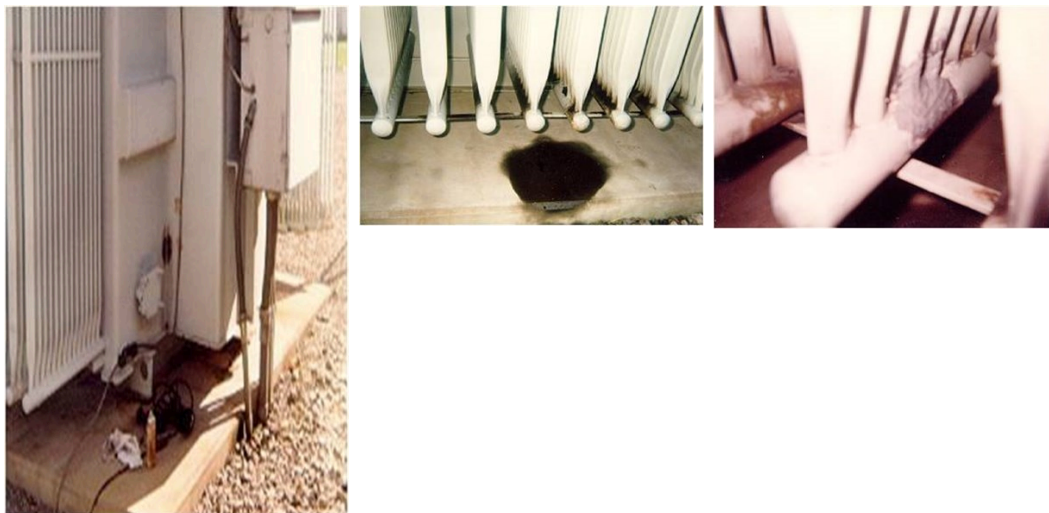
*Oil leaking from fins*

- \* General view of the transformer ,
- \* Close up of oil leak area ,
- \* Completed application. Leak sealed with Belzona® 1161 ,

Application was carried out in accordance with Belzona Know-How System Leaflet VPF-11a.

The costly need to drain down the oil to effect a repair was eradicated. The Belzona repair was carried out in less than 2 hours and has proven to be totally successful.
