# BELZONA SEALS SF6 LEAKS ON CIRCUIT BREAKER

Customer Location: Electrical distribution substation,  
Australia

Bushing on 330kV circuit breaker.

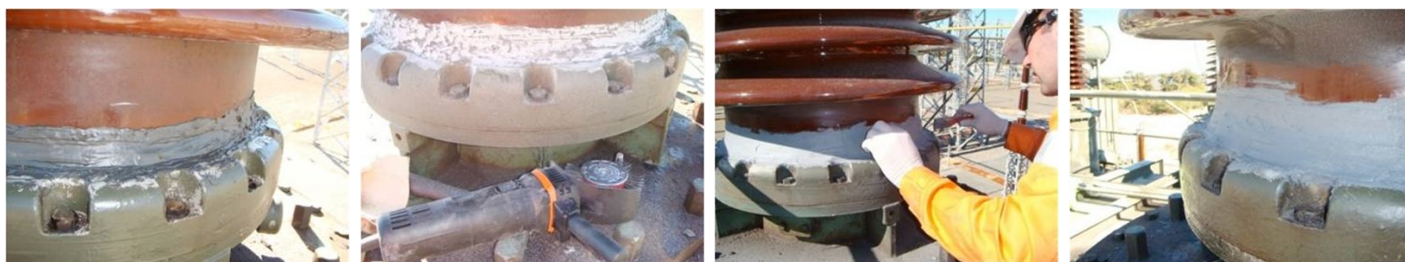
SF6 gas leaks through porcelain bushing seal

- \* Original unsuccessful repair (still leaking) ,
- \* Prepared area using the MBX Bristle blaster ,
- \* Applying the Belzona® 1161 ,
- \* Close up of the completed repair ,

Application was carried out in accordance with Belzona Know-How System leaflet VPF-11a. An MBX Bristle Blaster was used to prepare the surface before application of Belzona® 1161 to seal the leak area.

Application was carried out in an impressively simple and quick manner and created a totally successful gas tight seal where previous repair attempts had failed.
