BELZONA SEALS SF6 LEAKS ON GAS CHARGED CIRCUIT BREAKER

ID: 1488

Customer Location: *Power Company, UK*
Application Date: *2007*

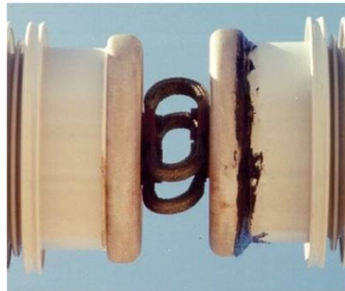
SF6 gas leaking through porcelain bushing seals

- * General view of the repair area (Top and Bottom) ,
- * Top bushing sealed ,
- * bottom bushing sealed ,

Application was carried out in accordance with a modified Belzona Know-How System Leaflet ENC-10. Following surface preparation to profile the metal and remove the glaze from the porcelain Belzona® 2311 was used to create an elastomeric seal.
