PROTECTION OF BOILER FEED PUMPS WITH BELZONA® 1391

Industry: *Chemical & Petrochemical*
Application: *CEP-Centrifugal Pumps*
Substrate: *Steel*
Products: ** Belzona® 1391 ,*

Customer Location: *Chemical Plant in Poland*
Application Date: *September 1995*

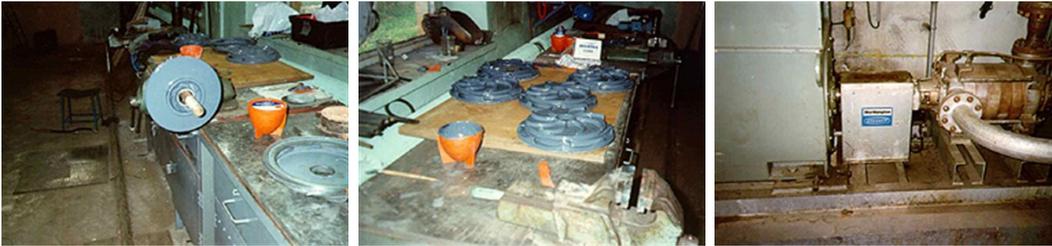
Erosion on the impellers and casing.

- * Application underway on one of the impellers. ,
- * Application complete. ,
- * Pump in service ,

Six stage boiler feed pumps operating at 105°C (220°F) and 50 bar pressure at 2950 rpm.

Application carried out in accordance with Belzona Know-How system CEP-3.

A total of five pumps have now been coated and original pump is still performing satisfactory after four years in service.
