PROTECTION OF BOILER FEED PUMPS WITH BELZONA® 1391

ID: 149

Customer Location: Chemical Plant in Poland
Application Date: September 1995

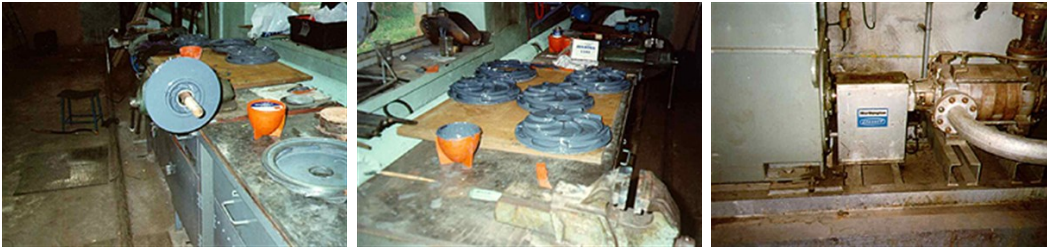
Photograph Descriptions

Erosion on the impellers and casing.

- * Application underway on one of the impellers. ,
- * Application complete. ,
- * Pump in service ,

Six stage boiler feed pumps operating at 105°C (220°F) and 50 bar pressure at 2950 rpm.

Application carried out in accordance with Belzona Know-How system CEP-3.

A total of five pumps have now been coated and original pump is still performing satisfactory after four years in service.
