BELZONA REPAIRS LIVE LEAK ON TRANSFORMER

ID: 1490

Customer Location: Electricity Distribution Company, UK
Application Date: 2007

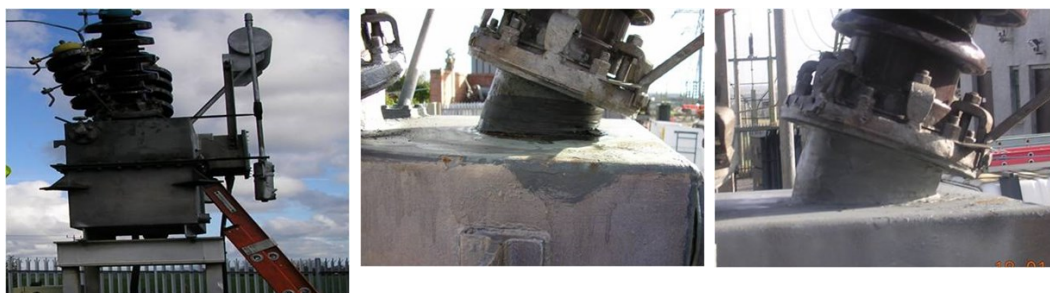
Photograph Descriptions

Oil leak causing environmental contamination.

- * Leak area ,
- * Leak stopped with Belzona® 1291 ,
- * Application completed with Belzona® 1161 ,

Pipework on oil filled transformer.

Application was carried in accordance with Belzona Know-How System leaflet VPF-11a. Belzona® 1291 used to firstly seal the live leak. The pipework was then encapsulated to prevent further leakage.

The costly need to drain down the oil to effect a repair (£8,000) was eradicated, the Belzona repair was carried out in less than 2 hours.
