BELZONA REPAIRS LEAKING TRANSFORMER FINS

ID: 1492

Customer Location: Wind Farm, UK
Application Date: 2007

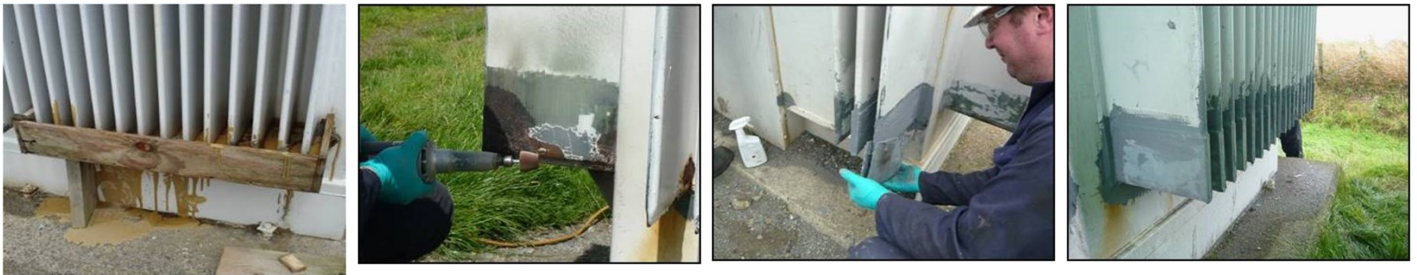
Photograph Descriptions

Lower edge of fins corroded and starting to leak. Problem caused by sheep rubbing against fins, damaging paint system.

- * Previous temporary repair ,
- * Surface preparation ,
- * Bonding with Belzona® 1161 ,
- * Completed application ,

Application was carried out in accordance with Belzona Know-How System Leaflet TCC-1. Pre-formed doubler plates were bonded over the corroded areas after manual surface preparation.

Client had tried unsuccessfully to seal leaks before turning to Belzona. The Belzona® 1161 provides an effective bond in oil contaminated areas and use of doubler plates ensures repair will remain effective for many years.
