# BELZONA SEALS LEAKING OIL PUMP

ID: 1493

**Customer Location:** Oil company, Japan  
**Application Date:** January, 2010

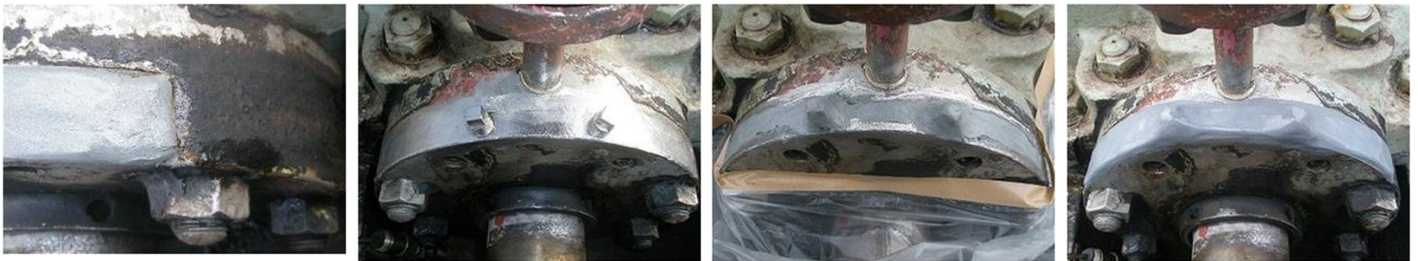
## Photograph Descriptions

Oil was leaking from several parts of mechanical seal flanges.

- \* Seal area before application ,
- \* Surface preparation completed ,
- \* Application of Belzona® 1221 ,
- \* Application completed ,

Application was carried out in accordance with a modified version of Belzona Know-How System Leaflet VPF-11a. Surface was prepared with an MBX Bristle Blaster and initial leaks were temporarily sealed with Belzona® 1221 before permanent sealing with Belzona® 1161.
