BELZONA PROTECTS NEW HEAT EXCHANGER

ID: 1495

Industry: Heating, Ventilation & Air Conditioning
Application: HEX-Heat Exchangers
Substrate: Cast iron
Products: * Belzona® 1321 (Ceramic S Metal),

Customer Location: HVAC company, Colorado
Application Date: June 2010

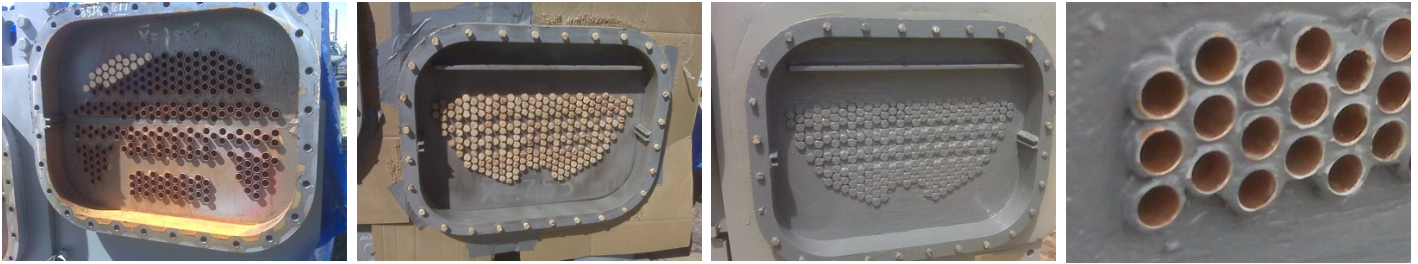
Photograph Descriptions

- * New chiller from factory ,
- * Blasted and corked tube-sheet ,
- * Belzona barrier system applied ,
- * Honed and cleaned tubes ,

New chiller tube-sheet and end covers

Application was carried out in accordance with Belzona Know-How System Leaflet HEX-2. After blasting tube-sheet and end covers components were coated with Belzona® 1321.
