# BELZONA STOPS LEAK DRAIN PIPE AND HOT WELL PUMP

*Leaking drain pipe and hot well pump at Water Treatment Plant*

Drain pipe and hot well pump of a condenser

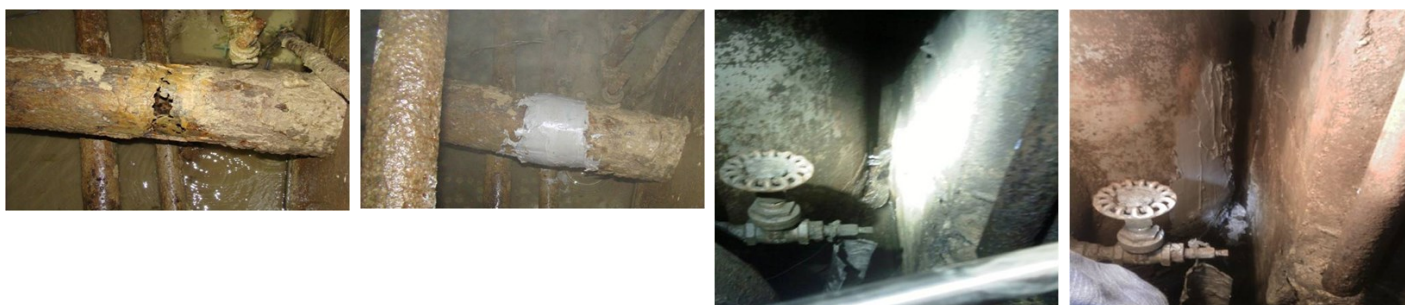
- \* 1. Overview of the large sized hole on drain pipe ,
- \* 2. To seal with Belzona 1161 ,
- \* 3. Live leaks of hot well pump ,
- \* 4. Stop leak with Belzona 1291 and Belzona 1161 ,

The application was carried out in accordance with a modified of Belzona Know-How System Leaflet HEX-9 and CEP-6 . First, Belzona 1291 was used to stop the leak, then Belzona 1161 along with Belzona 9341 covered the area.
