BELZONA SEALS GASOLINE STORAGE TANK

Industry: Chemical & Petrochemical
Application: TCC-Tanks and Chemical Containment Areas
Substrate: Steel
Products: * Belzona® 1161 (Super UW Metal) ,

Customer Location: Petrochemical plant, Ontario, Canada
Application Date: Summer 2008

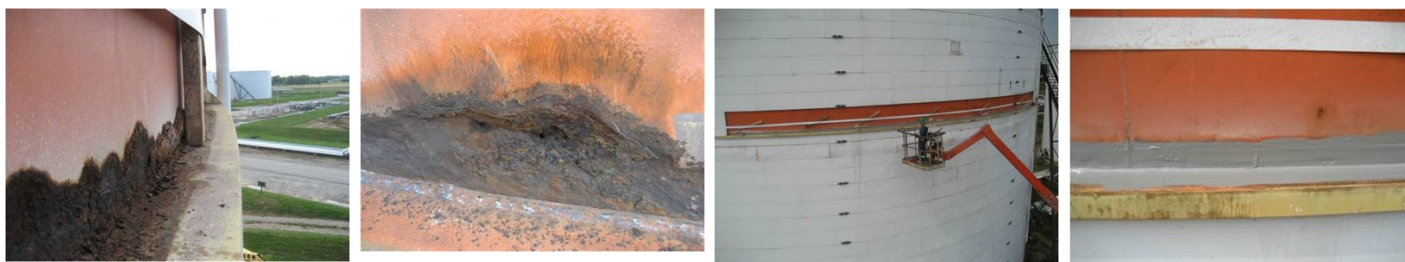
Photograph Descriptions

Water was collecting on this large reinforcement seam causing extensive corrosion.

- * Large corrosion area ,
- * Severity of corrosion clearly evident ,
- * Use of crane lift to access repair area ,
- * Completed Application ,

Application was carried out in accordance with Belzona Know-How System Leaflet TCC-1. The application was completed from the support equipment (crane).

Belzona® 1161 was used due to the difficulty in accessing and removing all condensation in the repair area. The application is in excellent condition until today without any problems.
