BELZONA FOR A CONCRETE COOLING TOWER BASIN

Customer Location: Nuclear Power Plant in the Northeast,
U.S.A.

Application: TCC-Tanks and Chemical Containment
Areas

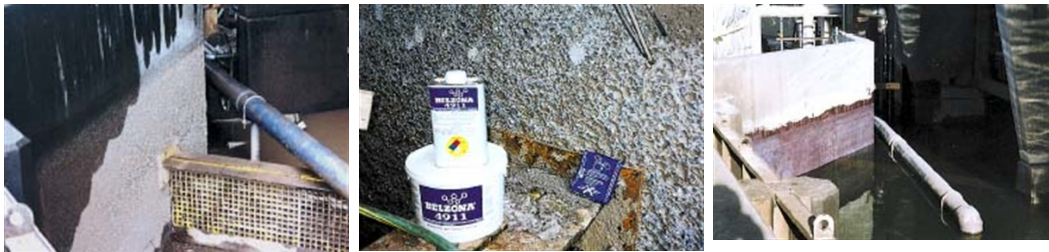
Photograph Descriptions

Sulfuric acid is injected into the cooling water to stop M.I.C. (microbiological induced corrosion). This severely damaged the concrete due to chemical attack and erosion three to four inches deep.

- * The damaged area. ,
- * Close-up view of severe erosion, the application of product ready to commence. ,
- * The completed repair, cooling tower basin in operation. ,

Application was carried out in accordance with Belzona Know-How Leaflet TCC-9.
