# BELZONA PROTECTION ON RIVER BARRAGE

Flood defence barrage on tidal river

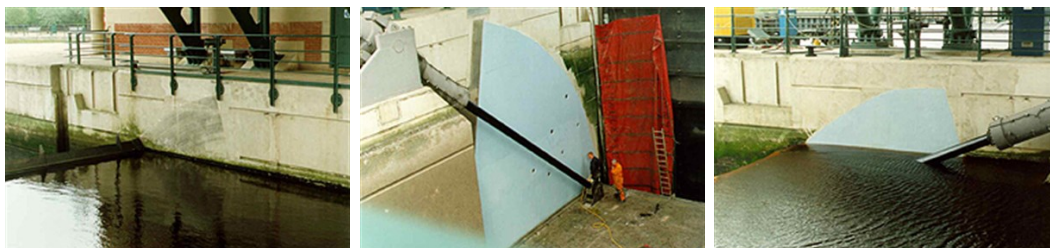
## Photograph Descriptions

*The rubber seals on the moving gates were being damaged by the concrete walls when the barrage was raised and lowered.*

- \* The abrasion from the rubber seals clearly evident on the concrete ,
- \* The completed application ,
- \* The barrage in action ,

Application carried out in accordance with Belzona Know-How system CEP-10.

Full scale application proceeded after initial trial proved 100% successful. Competitive system tried but could not be applied successfully. See KHIA Vol XXVI No 54 for update.
