BELZONA TRUNNION BEARING HOUSING REPAIR SAVES MONEY

ID: 1503

Customer Location: *Steel mill, Missouri*
Application Date: *Summer 2010*

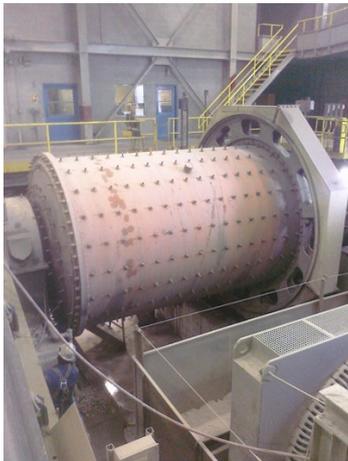
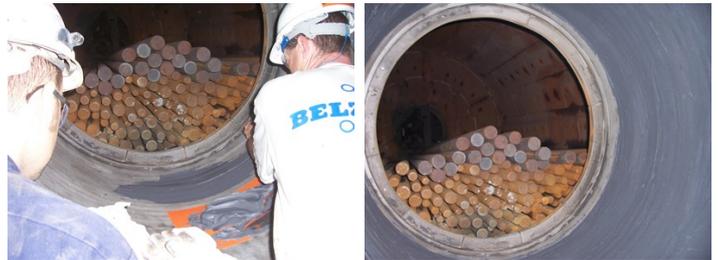
Photograph Descriptions

Bearing housing had allowed particulates to pass into housing and caused significant wear. Rod Mill downtime costs 20k per hour.

* Overview of Rod Mill Close up of worn housing Applying the Belzona® 1311 Final repair ,

Rod Mill trunion bearing housing had significant wear and insufficient downtime for traditional weld/machining repair.

Application was carried out in accordance with Belzona Know-How System Leaflet MPT-2. Housing was heated with torch to sweat out oils. The substrate was then blasted to a 2-3 mil profile. Application of the Belzona® 1311 followed to rebuild housing back to OEM specification.

Welding and Machining would have taken 7-10 days and the cost was \$40-60k not including downtime of the mill. Belzona application took 8 hours start to finish and at a significantly lower cost.
