# BELZONA TRUNNION BEARING HOUSING REPAIR SAVES MONEY

Customer Location: *Steel mill, Missouri*  
Application Date: *Summer 2010*

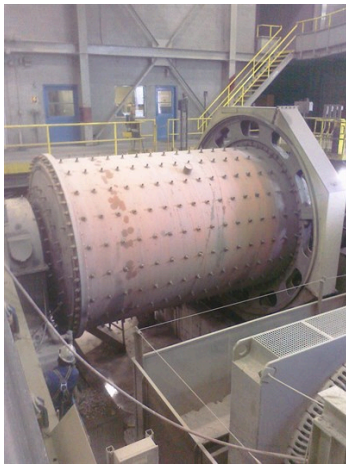
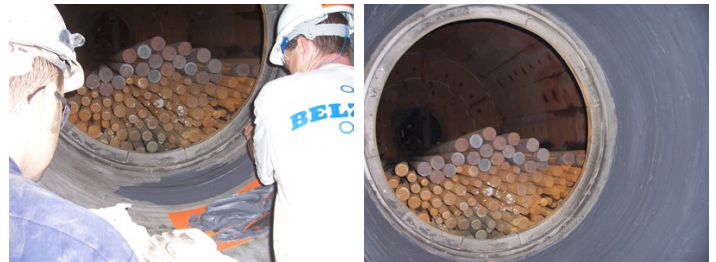
*Bearing housing had allowed particulates to pass into housing and caused significant wear. Rod Mill downtime costs 20k per hour.*

\* Overview of Rod Mill Close up of worn housing Applying the Belzona® 1311 Final repair ,

Rod Mill trunion bearing housing had significant wear and insufficient downtime for traditional weld/machining repair.

Application was carried out in accordance with Belzona Know-How System Leaflet MPT-2. Housing was heated with torch to sweat out oils. The substrate was then blasted to a 2-3 mil profile. Application of the Belzona® 1311 followed to rebuild housing back to OEM specification.
