RUBBER PUMP LINERS REPAIRED WITH BELZONA

ID: 1505

Industry: *Mining & Quarrying*
Application: *SHM-Solids Handling Machinery*

Customer Location: *Mine, Namibia*
Application Date: *July 2009*

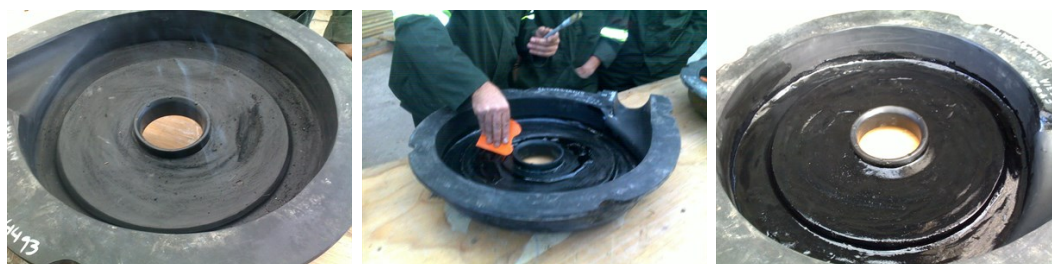
Slurry product destroys rubber liners in 3 weeks.

* Damaged rubber liner Rubber liner being coated with Belzona® 2111 Rubber liner after application of Belzona® 2111 ,

Application carried out in accordance with Belzona Know-How System Leaflet SHM-9. Belzona Roughing Brush used to prepare surface before Conditioning then rebuilding with Belzona® 2111.

The rubber liners coated with Belzona® 2111 are currently lasting 3 times longer than OEM parts. The cost to repair is also lower than a new liner.
