NOVEL REPLACEMENT OF GUTTER IN CHEMICAL PLANT USING BELZONA

ID: 1513

Customer Location: Chemical Plant, France

Products: * Belzona® 4311 (Magma CR-1),
* Belzona® 4151 (Magma Resins),

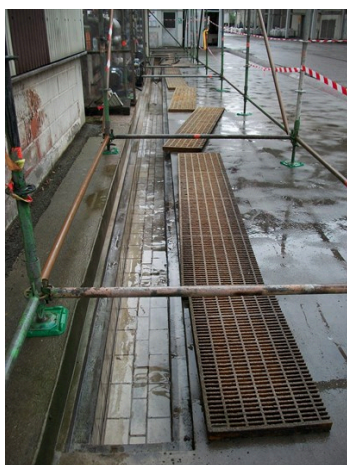
The original gutter was made of tiles which became soft and porous.

- * Damaged gutter ,
- * New steel gutter ready to be installed ,
- * Steel gutter grouted into place with Belzona® 4151 ,
- * Belzona® 4311 applied to completely seal grout and surrounding concrete ,
