# SAND FILTER LINING REPAIRED WITH BELZONA

**Industry:** Chemical & Petrochemical  
**Application:** TCC-Tanks and Chemical Containment Areas

**Customer Location:** Chemical company, Martorell, Spain  
**Application Date:** March 2010.

Ebonite lining in sand filter

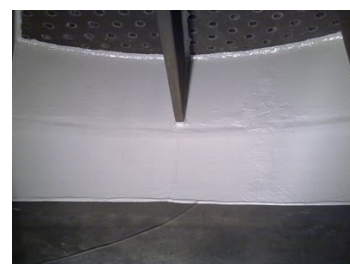
The ebonite lining showed severe degradation (cracks, grooves, gasket failure, adhesion problems) due to the corrosive action of the solution (brine 250 gr/Kg, active Cl<sub>2</sub> 0-20 ppm) at 65°C.

- \* View of the filter from outside ,
- \* Degraded area, cracked ebonite ,
- \* Rebuilding with Belzona® 1111 ,
- \* Ebonite coated with Belzona® 5891 ,

The application was carried out in accordance with Belzona Know-How System Leaflet TCC-3 & 5.

Thanks to the Belzona products, the filter was back in service after a rapid, easy and in situ repair. The cost of replacing ebonite would have been much higher. Belzona enabled a quick in-situ repair to be carried out, ensuring filter could returned to service with minimum disruption to production. Alternative (replacing ebonite) would have taken far longer and at far higher cost
