BELZONA SOLUTION TO ABRASION AT COAL MINE

ID: 1519

Industry: Mining & Quarrying
Application: SHM-Solids Handling Machinery

Customer Location: Coal Mine, Southern Illinois
Application Date: August 2010

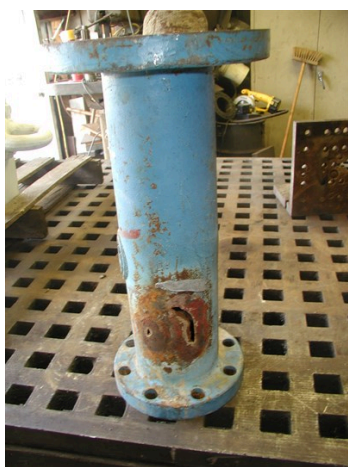
Excessive wear and costly replacement brought on by abrasion from coal dust. The coal chute and lateral fitting have an average operating temperature of 200°F. Due to excessive wear pipes were only lasting a few weeks before needing to be replaced. A cost effective alternative to replacement was being sought.

* View of holed lateral fitting Close up of inside damage Interior view of completed application Outside view of completed application ,

Application was carried out using a modified version of Belzona Know-How System Leaflet SHM-13. The interior cavity was filled with Belzona® 1811 and a "hard back" was formed on the outside to give maximum thickness for abrasion resistance. Inside was lined with Belzona® 1391 overlaid with aluminum oxide. application was then post cured for maximum resistance.
