# BELZONA SOLUTION TO ABRASION AT COAL MINE

ID: 1519

Industry: Mining & Quarrying  
Application: SHM-Solids Handling Machinery

Customer Location: Coal Mine, Southern Illinois  
Application Date: August 2010

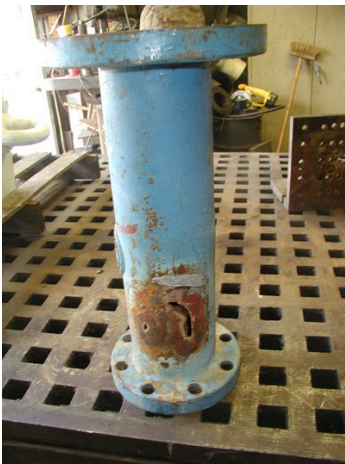
Excessive wear and costly replacement brought on by abrasion from coal dust. The coal chute and lateral fitting have an average operating temperature of 200°F. Due to excessive wear pipes were only lasting a few weeks before needing to be replaced. A cost effective alternative to replacement was being sought.

\* View of holed lateral fitting Close up of inside damage Interior view of completed application Outside view of completed application ,

Application was carried out using a modified version of Belzona Know-How System Leaflet SHM-13. The interior cavity was filled with Belzona® 1811 and a "hard back" was formed on the outside to give maximum thickness for abrasion resistance. Inside was lined with Belzona® 1391 overlaid with aluminum oxide. application was then post cured for maximum resistance.
