BELZONA LEAK SEALING ON VALVES

ID: 152

Industry: *Water / Wastewater*
Application: *VPF-Valves, Pipes and Fittings*
Substrate: *Cast iron and steel*
Products: ** Belzona® 1311 ,*
** Belzona® 1321 (Ceramic S-Metal) ,*

Customer Location: *Ministry of Water, Jordan*
Application Date: *1998*

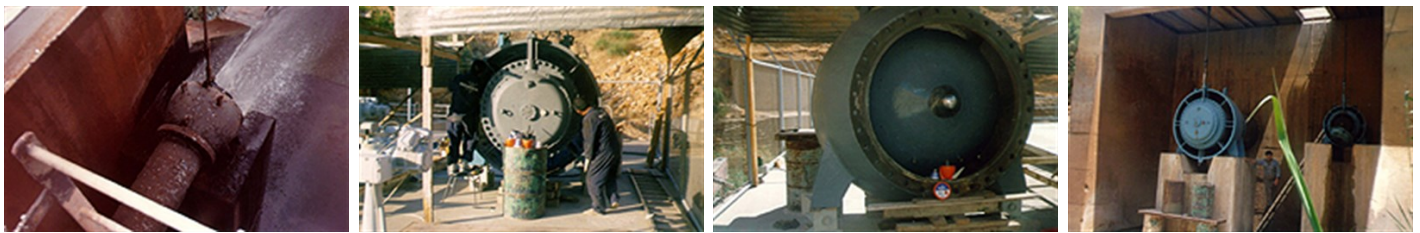
Photograph Descriptions

Erosion-corrosion leading to water leakage.

- * The degree of water leakage clearly evident from the 1.6m valve ,
- * Work underway on the 2.2m valve ,
- * Application completed ,
- * The two valves re-installed at the dam base ,

Emergency water valves, 1.6m and 2.2m diameter, in dam.

Application was carried out in accordance with Belzona System Leaflets VPF-1 and VPF-2.

The larger valve was repaired following successful refurbishment of the smaller one.
