# REPAIR AND PROTECTION OF HOSPITAL LAUNDRY FLOOR WITH BELZONA

ID: 1523

Customer Location: Hospital, Scotland  
Application Date: Oct/ Nov 2009

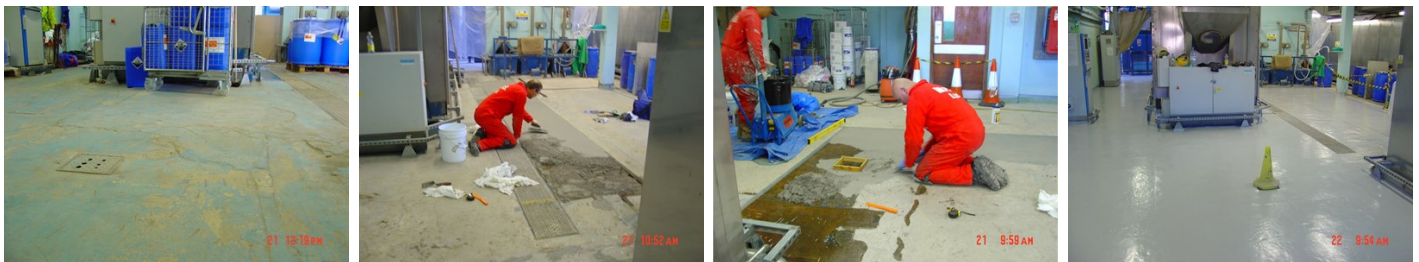
## Photograph Descriptions

The laundry floor of this hospital was not level and water was gathering in the middle of the floor. They needed the floor to be re-levelled so that water ran to the drains. The floor also had to be safe from accidents.

\* Uneven, damaged laundry floor Application of Belzona® 4131 Application of Belzona® 4131 Completed application ,

Application was carried out in accordance with Belzona Know-How System Leaflet FPA-1. Existing floor was cut out to create a fall and then screeded over with Belzona® 4131. This was then overcoated with Belzona® 5231.

The use of Belzona® 4131 allowed falls to be created with minimum disruption to hospital operations. the Belzona® 5231 provided a safe surface for operatives in the laundry. The hospital are now currently looking at improving the safety throughout the building utilising Belzona solutions.
