BELZONA REPAIRS TO SPALLED CONCRETE

Industry: General Industry
Application: RPA-Roof Problem Areas
Substrate: Concrete and steel
Products: * Belzona® 4141 (Magma-Build) ,
* Belzona® 5151 (Hi-Build) ,

Customer Location: Art college in U.K.
Application Date: 1996

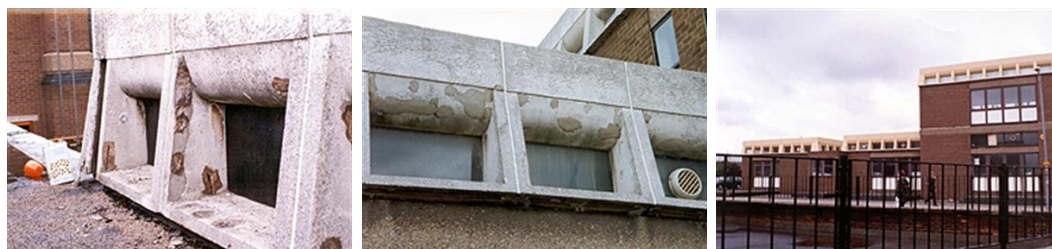
Carbonation of the concrete allowing corrosion of the steel reinforcing leading in turn to serious spalling of the concrete.

- * Some of the extensive spalling prepared and conditioned ,
- * Belzona® 4141 applied to rebuild the spalled concrete ,
- * Completed application ,

Application was carried out in accordance with Belzona System Leaflet RPA-2.

Permanent repairs were carried out with minimum access time. Belzona coating will prevent further carbonation on surrounding areas.
