# BELZONA REPAIRS TO SPALLED CONCRETE

ID: 154

**Customer Location:** Art college in U.K.  
**Application Date:** 1996

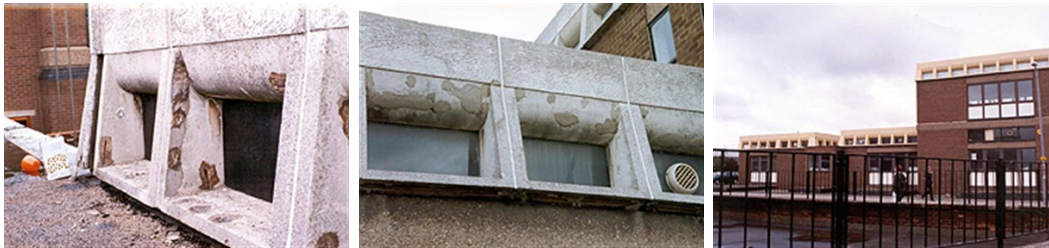
*Carbonation of the concrete allowing corrosion of the steel reinforcing leading in turn to serious spalling of the concrete.*

- \* Some of the extensive spalling prepared and conditioned ,
- \* Belzona® 4141 applied to rebuild the spalled concrete ,
- \* Completed application ,

Cast concrete perimeter roof detail

Application was carried out in accordance with Belzona System Leaflet RPA-2.

Permanent repairs were carried out with minimum access time. Belzona coating will prevent further carbonation on surrounding areas.
