BELZONA® 3111 WEATHERPROOFS PROBLEM ROOF

ID: 155

Customer Location: Property managers, U.K.
Application Date: 1987

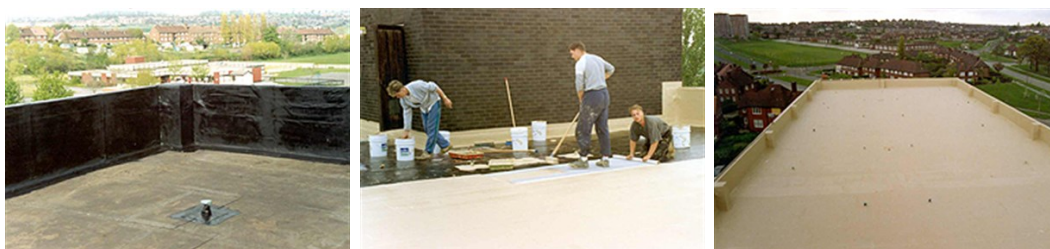
Photograph Descriptions

Deterioration of original felt finish had allowed water ingress into the roof deck. In particular the roof insulation had become saturated. Traditional repairs had not been successful.

- * The original roof surface with new breather vents installed ,
- * Application underway. Note detail application to flashings and parapet wall ,
- * Completed application ,

Application was carried out in accordance with Belzona System Leaflets RPA-6, RPA-8, and RPA-10. Breather vents were also installed to allow the insulation to dry out.

Use of Belzona® 3111 has allowed long term weatherproofing to be achieved with minimal disruption to the building. The original roof covering did not need to be stripped off and occupation of the top floors continued unhindered. Inspected in 1996, the roof was 100% watertight.
