BELZONA BELT SWAT TEAM

ID: 156

Application: *SHM-Solids Handling Machinery*

Customer Location: *Paper Mill in Jacksonville, Florida*

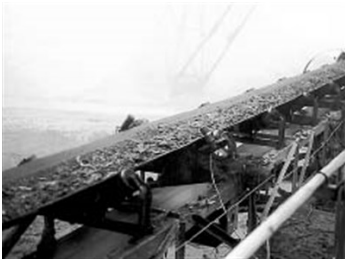
A small hole under belt tension is expected to get larger and debris was leaking through the belt.

- * Belt delivers bark to powerhouse, 24 hours a day, 7 days a week ,
- * Surface preparation completed using Belzona roughening brush, and Belzona® 2911 (Q.D. Conditioner) is applied ,
- * Hole successfully patched by the happy crew (Belt Swat Team)! ,
