NOZZLE IN ACID TANK PROTECTED WITH BELZONA INSERT

ID: 1572

Customer Location: Chemical manufacturer, Cataluña, Spain
Application Date: October 2010

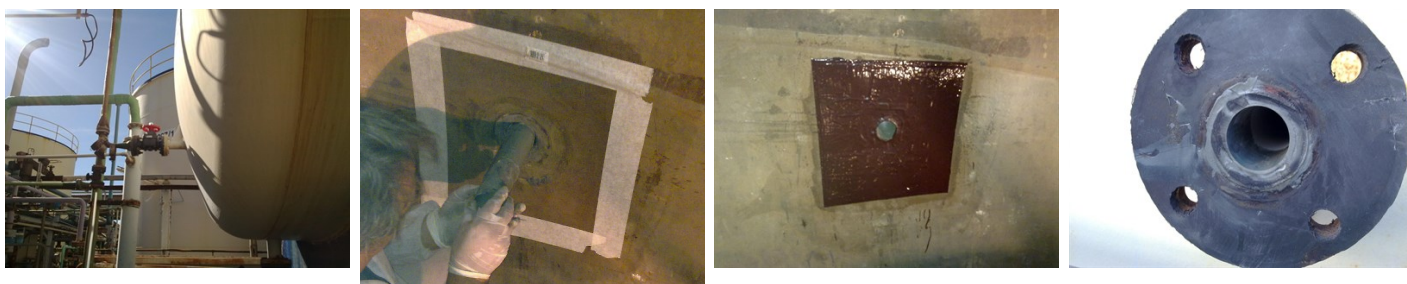
Photograph Descriptions

The interior of an ebonite lined nozzle handling 26% Hydrochloric acid had suffered damage.

- * Outer view of the tank and nozzle ,
- * Belzona® 4301 Nozzle Insert being installed ,
- * Surrounding Ebonite rebuilt with Belzona® 4301 to seal the insert ,
- * Insert sealed at the flange ,

The application was carried out according to the Belzona Know-How System Leaflets TCC-16a and TCC-16b. Nozzle was made from Belzona® 4301 and bonded into place with Belzona® 4311.
