BELZONA PROVEN PROTECTION FOR SEDIMENTATION TANK

ID: 1574

Customer Location: *Pharmaceutical producer, Slovakia*
Application Date: *1998 to September, 2010*

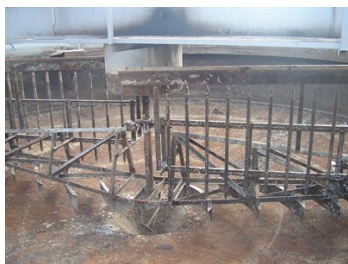
The tanks suffer from severe corrosion.

- * Tank showing severe corrosion ,
- * Grit-blasting the tank ,
- * Setting up the spray equipment ,
- * Tank after the application ,
