# BELZONA FLOOR REPAIRS IN CIDER FACTORY

Industry: Buildings & Structures  
Application: FPA-Floor Problem Areas  
Substrate: Concrete  
Products: \* Belzona® 4131 (Magma Screed) ,

Customer Location: Cider Manufacturer, UK  
Application Date: 2009

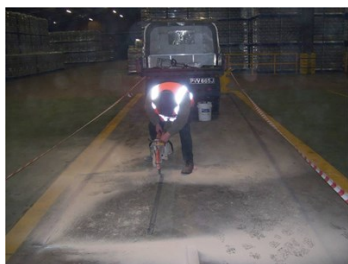
Lorry trailers park here and the stabilisers when lowered damage the floor area after 6-8 months.

- \* Preparation of damaged area ,
- \* Application of Conditioner ,
- \* Applying Belzona® 4131 ,
- \* Completed Application ,

Application was carried out in accordance with Belzona Know-How System Leaflet FPA-1.

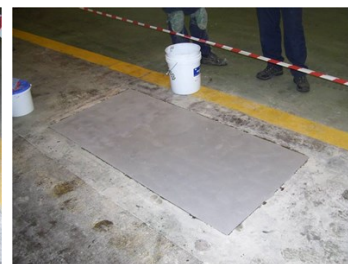
The repairing and protection of the floor in these localised areas with Belzona® 4131 resists both impact and abrasion thus extending the life of the floor area leading to reduced maintenance. The customer was very pleased with the results and this job
