BELZONA FLOOR REPAIRS IN CIDER FACTORY

ID: 1575

Customer Location: Cider Manufacturer, UK
Application Date: 2009

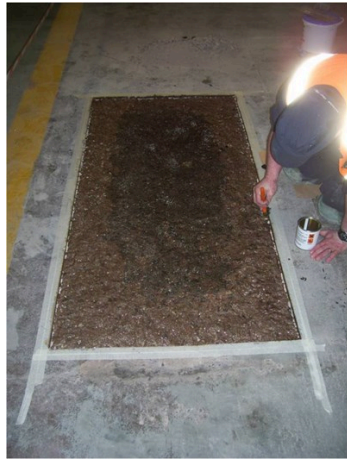
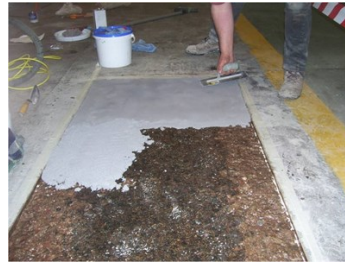
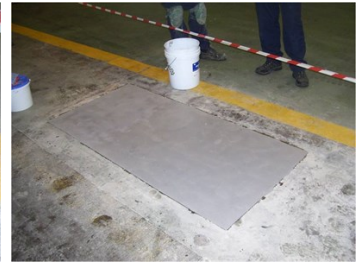
Photograph Descriptions

Lorry trailers park here and the stabilisers when lowered damage the floor area after 6-8 months.

- * Preparation of damaged area ,
- * Application of Conditioner ,
- * Applying Belzona® 4131 ,
- * Completed Application ,

Application was carried out in accordance with Belzona Know-How System Leaflet FPA-1.

The repairing and protection of the floor in these localised areas with Belzona® 4131 resists both impact and abrasion thus extending the life of the floor area leading to reduced maintenance. The customer was very pleased with the results and this job
