# BELZONA PROVIDES LONG TERM SOLUTION IN COOL ROOMS

**Industry:** General Industry  
**Application:** FPA-Floor Problem Areas  
**Substrate:** Concrete  
**Products:** \* Belzona® 4131 (Magma Screed) ,  
\* Belzona® 2221 (MP Fluid Elastomer) ,  
\* Belzona® 5811 (Immersion Grade) ,

**Customer Location:** Poultry Plant, Virginia  
**Application Date:** 1995

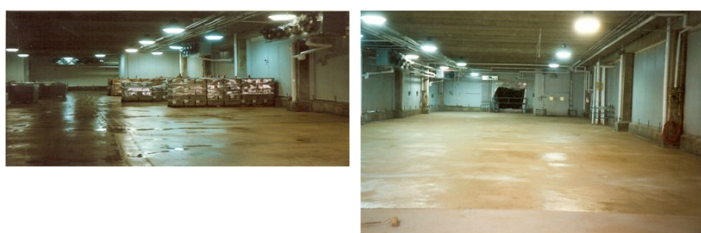
- \* Second Floor Cooler ,
- \* After Original Application ,
- \* Floor After 14 Years ,
- \* Only Small Damage Present ,

Second floor cooler (8500 ft<sup>2</sup>) was leaking onto the cooler on the lower floor.

After 14 years the floor was still water proof and without any leaks. Some scratches were present due to metal wheeled fork lifts but no water penetration. Small areas were touched up. Customer was very happy with longevity of the application.

USDA inspectors made it clear that the leaks needed to be stopped. Floor needed to be repaired, coated and expansion joints sealed.

Application was carried out in accordance with Belzona Know-How System Leaflets FPA-1 & FPA-6.
