# GAS LINE REPAIRED WITH BELZONA SUPERWRAP SYSTEM

Customer Location: Oil Refinery, Argentina  
Application Date: March, 2010

18" Gas Line transporting natural gas

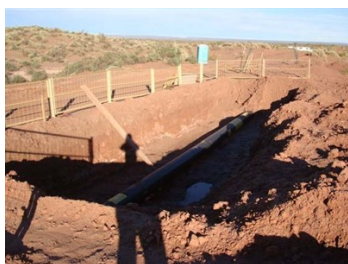
Gas line was suffering from wall thickness loss due to internal corrosion. A thin wall defect of dimensions 2.1x2.4x0.25" was detected on a section of the pipework.

- \* Gas Line exposed ,
- \* Surface Preparation by Sponge Jet ,
- \* Applying product around the pipework section ,
- \* Application completed ,
