# BELZONA CONTRIBUTES TO PUMP EFFICIENCY PROGRAMME IN STEEL PLANT

Industry: *General Industry*  
Application: *CEP-Centrifugal Pumps*  
Substrate: *Steel*  
Products: *\* Belzona 1111 (Super Metal) ,*  
*\* Belzona 1341 (Supermetalglide) ,*

Customer Location: *Steel plant, Hungary*  
Application Date: *2010*

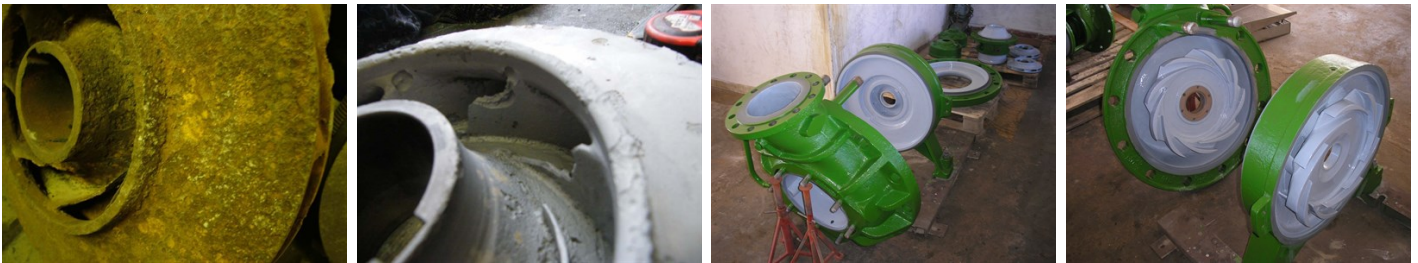
*Damage due to erosion and corrosion caused high efficiency loss. The 12 selected pumps are 15 years old. But there are another 60 pumps 30-36 years old which have certainly higher efficiency loss as the tested ones.*

- \* Pump surface before coating ,
- \* Grit blasted impeller ,
- \* Coated parts ,
- \* Coated housing ,

Application was carried out in accordance with Belzona Know-How System Leaflet CEP-10.

Steelmill installed new digital control system for the proper monitoring of power consumption, volume and water pressure. Before and after result: -10-12% less power consumption +12,5% more pressure +12,5% higher head. The energy saving in a year covers
