BELZONA RESTORES HYGIENE LEVELS IN SWEET/CANDY MANUFACTURER

ID: 1585

Application: WPA-Wall Problem Areas

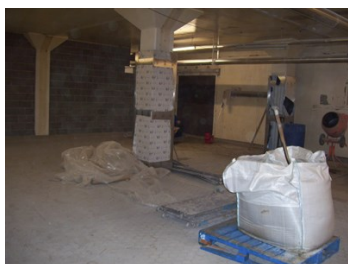
- * 1. Kitchen area to be coated ,
- * 2. Belzona 5911 (Ceramic Conditioner) being applied ,
- * 3. Completed wall coating ,
- * 4. Wall coating revisited 12 years later ,

Concrete Repair and coating required to internal walls.

Application was carried out in accordance with Belzona Know-How System Leaflets WPA-2 & 4. The damaged areas were repaired using Belzona 4141 to ensure smooth surface for application of the Belzona 5111 System.

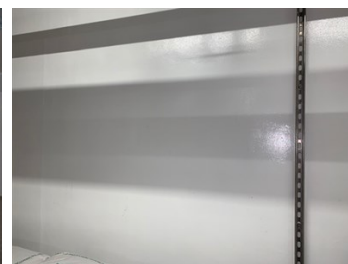
Initially 1/3 of the kitchen areas were refurbished with the Belzona System. Since then the customer has been so pleased with the results that they plan to complete the rest of the kitchen areas. 12 years later, the coating is still in great condition proving a highly decorative, non-toxic wall surface which is easy to clean.
