# BELZONA REBUILDS BAKERY FLOOR

ID: 1587

**Industry:** General Industry  
**Application:** FPA-Floor Problem Areas  
**Substrate:** Concrete  
**Products:** \* Belzona® 4131 (Magma Screed) ,  
\* Belzona® 2221 (MP Fluid Elastomer) ,

**Customer Location:** Bakery, Northern Ireland  
**Application Date:** August 2009

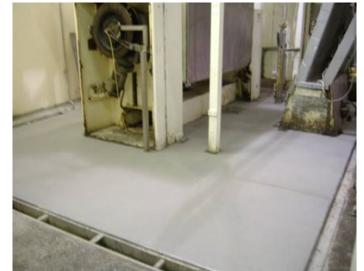
Oils, flour and cleaning water were going under the dough mixing machine. Falls needed to be created to enhance drainage and ease of cleaning in this hygiene area.

- \* Floor problem area ,
- \* Floor area after cleaning and abrasion ,
- \* Belzona Conditioner being applied ,
- \* Floor area screeded with Belzona® 4131 ,

Floor area around dough making machine.

Application was carried out in accordance with Belzona Know-How System Leaflets FPA-1 & 6. A flexible seal using Belzona® 2221 was included to absorb the machines vibrations and to prevent foodstuffs from going under the machine.
