BELZONA UPGRADE TO FLOOR IN CHOCOLATE FACTORY

ID: 1588

Customer Location: Chocolate manufacturer, Derbyshire, UK
Application Date: December 2009

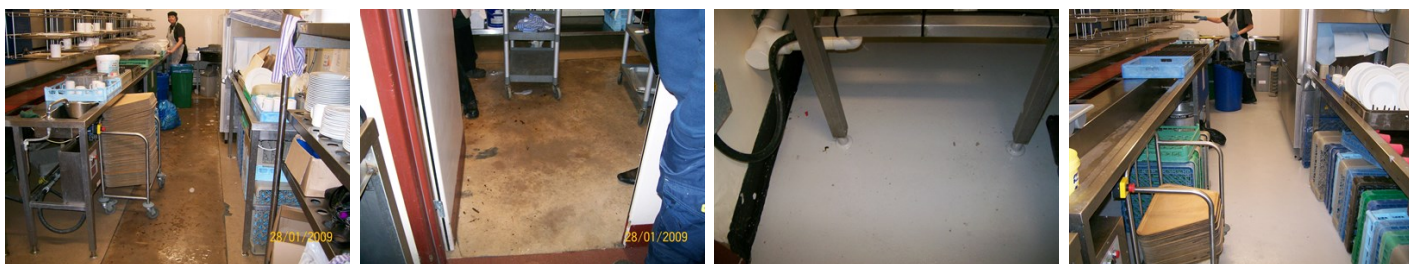
Photograph Descriptions

The existing coating had begun to deteriorate and sections of the main walk area had been removed exposing the concrete substrate beneath. This was not only unsightly; it also represented a health risk as staff were unable to clean the floor area adequately as food particles become trapped in the surface. The area also presented a considerable slip risk.

- * Floor Areas to be Repaired ,
- * Floor Areas to be Repaired ,
- * Completed Floor Application ,
- * Completed Floor Application ,

The remainder of the original floor coating was uplifted and the whole concrete floor area Application was carried out in accordance with Belzona Know-How System Leaflet FPA-3.

The clients requirements and expectations have been met in full and they are very pleased with the results. the floor provides a hygienic surface that cannot harbour bacteria and also provides a slip resistant surface for the staff.
