# BELZONA REPAIRS AND WATERPROOFS OFFSHORE ROOF

Application: RPA-Roof Problem Areas

Customer Location: Oil Producer, Gulf of Mexico.

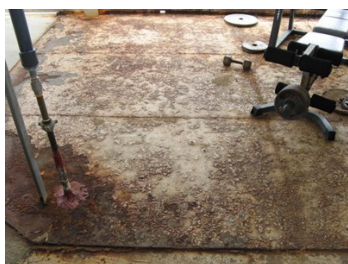
Customer seeking roof repair and installation of waterproofing system without disrupting oil and gas production. Metal roof had severe corrosion resulting in thin wall and some holes through the plates.

- \* Roof showing severe corrosion ,
- \* Roof after grit blasting ,
- \* Roof after repairs and first coat Belzona 3111 ,
- \* Roof after completion ,

Application was carried out in accordance with Belzona System Leaflets RPA-1, RPA-6 and TCC-1. Belzona 1121 was used to bond doubler plates over thinned and holed areas before applying a fully reinforced Belzona 3111 System over the entire area.
