# BELZONA PROOFING BOX FLOOR FOR SUPERMARKET

Application: FPA-Floor Problem Areas

Substrate: Concrete

Products: \* Belzona® 4111(Magma Quartz),

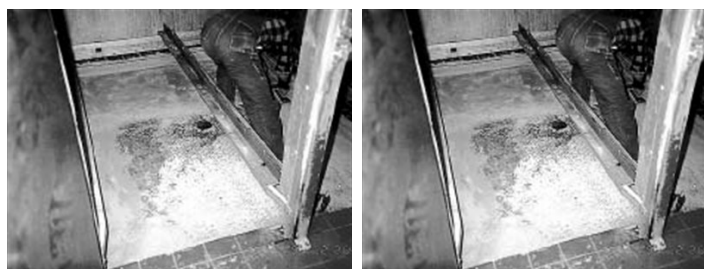
## Photograph Descriptions

The proofing boxes in the bakeries is where bakery products are put to cause the dough to rise. Temperature is held at 100°F. Repairs required a U.S.D.A. approved food safe product.

- \* Partial application showing damaged concrete ,
- \* Completed application of proofing box ,

The application was carried out in accordance with Belzona Know-How Leaflet FPA-1.

These bakeries run 24 hours a day. One reason Belzona® 4111 was chosen is it has no offensive odor. The repair started around noon and finished by 2:00 p.m., allowing plenty of time for the Belzona® 4111 to cure before the next scheduled bakery shift at 2:00 a.m. the next morning. No odor was detected at 2:00 a.m. A total of 12 store proofing boxes were done.
