BELZONA UPGRADES FLOOR IN FOOD PREPARATION AREA

ID: 1596

Customer Location: School, UK
Application Date: October 2010

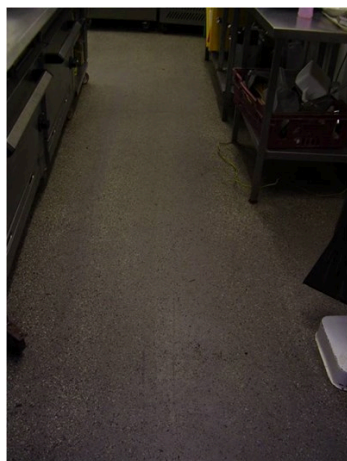
The floor was slippery creating a health and safety issue. In addition the concrete was being damaged around drains.

- * Floor Problem Area ,
- * Floor Problem Area ,
- * Completed Floor Application ,
- * Completed Floor Application ,

The application was carried out in accordance with Belzona Know-How System Leaflet FPA-3. The concrete was abraded to remove the existing coating before applying the 2 coat Belzona® 5231 system by roller.
