# BELZONA SAVES AGRICULTURAL CHEMICAL COMPANY \$3 MILLION

**Application:** TCC-Tanks and Chemical Containment Areas

10 ft. diameter x 12 ft. long filter drum used to manufacture Aureomycin

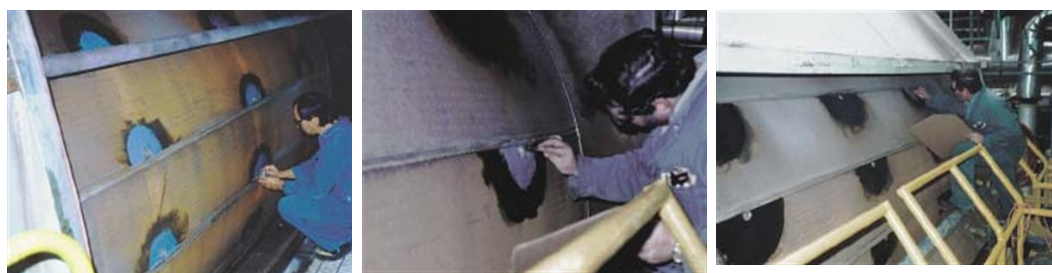
## Photograph Descriptions

Leaks developed at the welds joining the vacuum lines to the face of the drum. The inside diameter of the drum was so deteriorated that there was some flexing at the drum face.

- \* Belzona® 1221 around pipe, Belzona® 2311 on the drum around the Super E Metal patch ,
- \* Beginning Belzona® 2311 patches ,
- \* Completing Belzona® 2311 over Belzona® 1221 ,

The application was carried out in accordance with a modified version of Belzona Know-How Leaflet TCC-1.

After six weeks, the customer decided to check the repairs, believing that they were probably beginning to fail. Six repair areas were ground off, and no problems were observed. They were re-done as before, and the drum returned to service, saving the company over \$3 million.
